Bouquet Canyon Creek Restoration Project

Draft Initial Study/ Mitigated Negative Declaration

August 2016

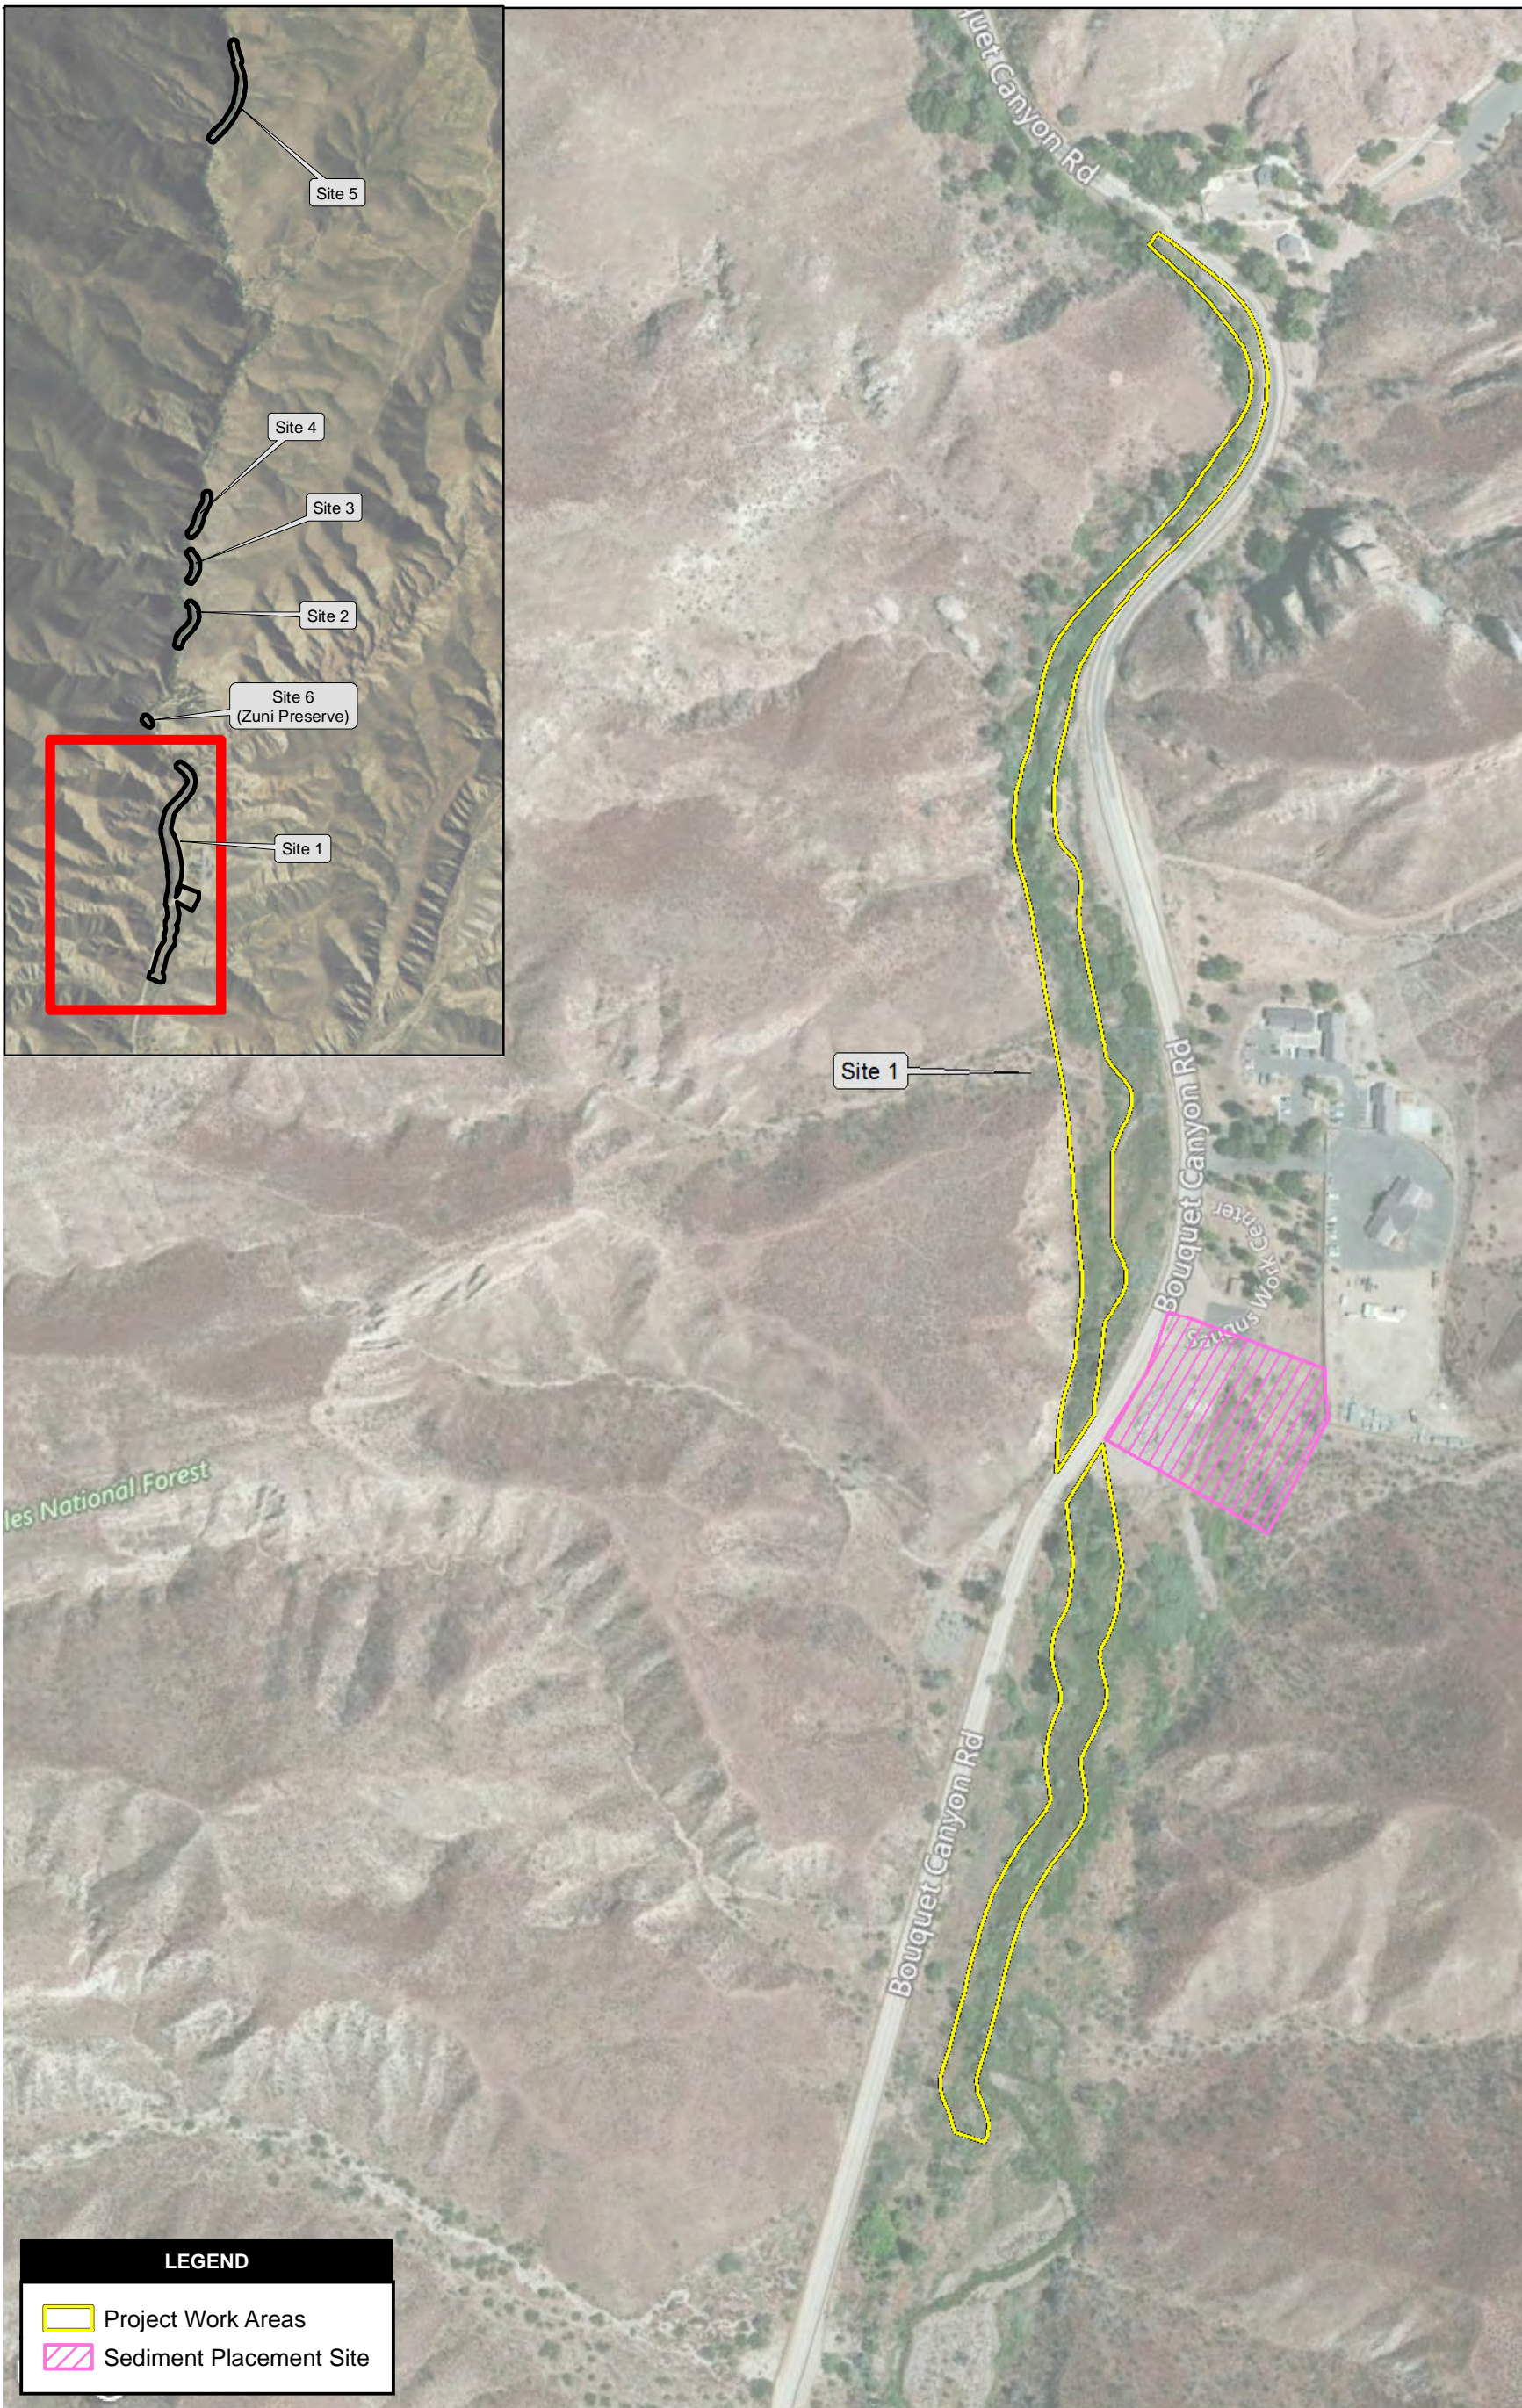
Figure 2-3
Project Work Limits

Flowing water is generally present in Bouquet Canyon Creek at Site 2, and water has been observed along the flow line of the roadway between 1,350 and 1,450 feet south of MM 14.70. The approximate project limits of Site 2 are depicted in Figure 2-4.

Site 3 contains flowing water in the existing creek bed, and water has been observed along the flow line of the roadway from MM 14.70 to 100 feet southerly. The approximate project limits of Site 3 are depicted in Figure 2-4.

Site 4 contains flowing water in the existing creek bed, and water has been observed to be present and flowing along the asphalt invert between 700 and 580 feet north of MM 14.70. Flows on the roadway exit the roadway back into the stream channel at an overshot located at 580 feet north of MM 14.70. The approximate project limits of Site 4 are depicted in Figure 2-4.

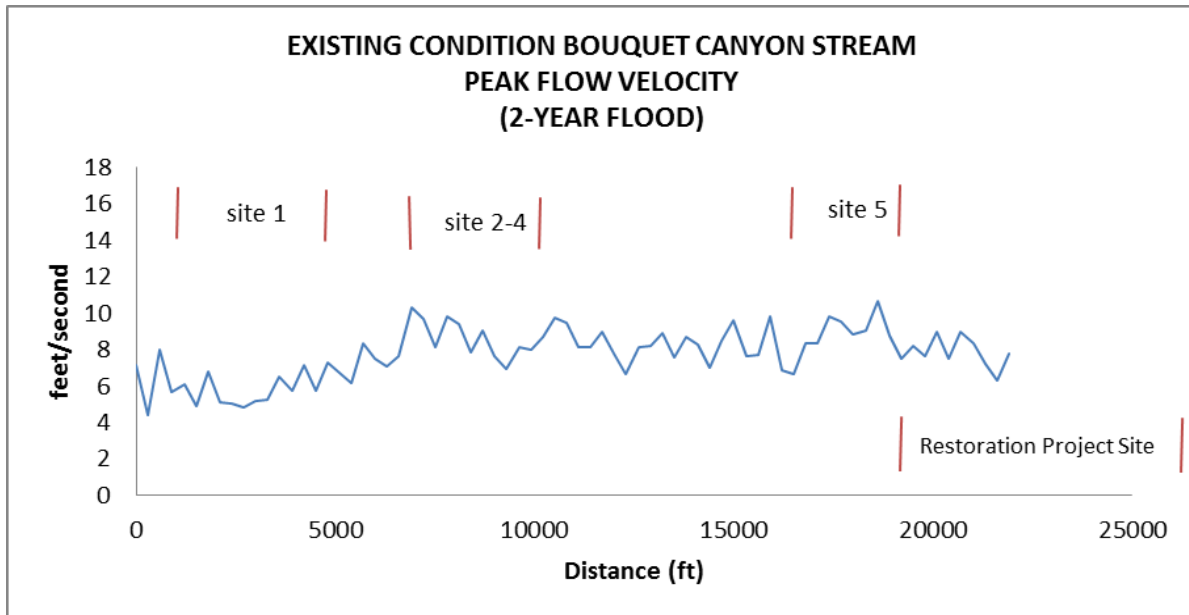
Figure 4. Bouquet Canyon Creek 2-year Flood Flow Velocity Profile under Existing Conditions

The U.S. Army Corps of Engineers' HEC-RAS backwater model was used to evaluate the hydraulic characteristics. Flow velocity and water surface elevations were computed for each of the 2-, 5-, 10-, 25-, and 50-year storm events. The flow velocity results were plotted and are shown in Figures 4 through 8.

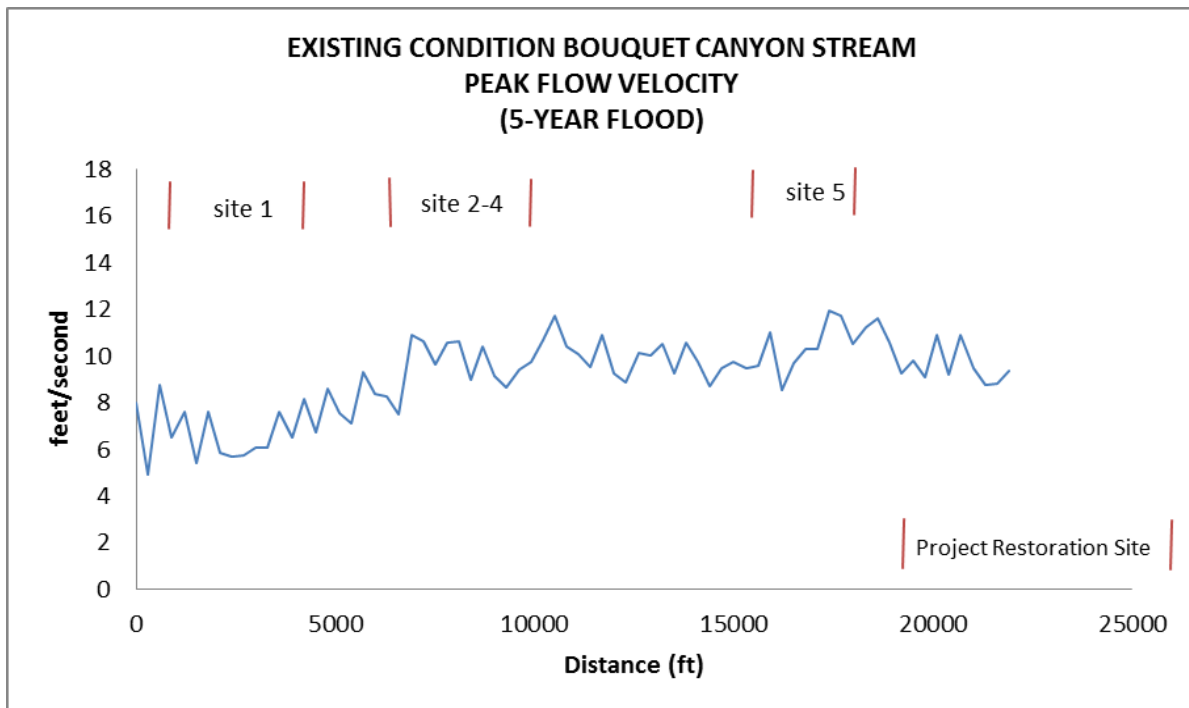
Figure 5. Bouquet Canyon Creek 5-year Flood Flow Velocity Profile under Existing Conditions

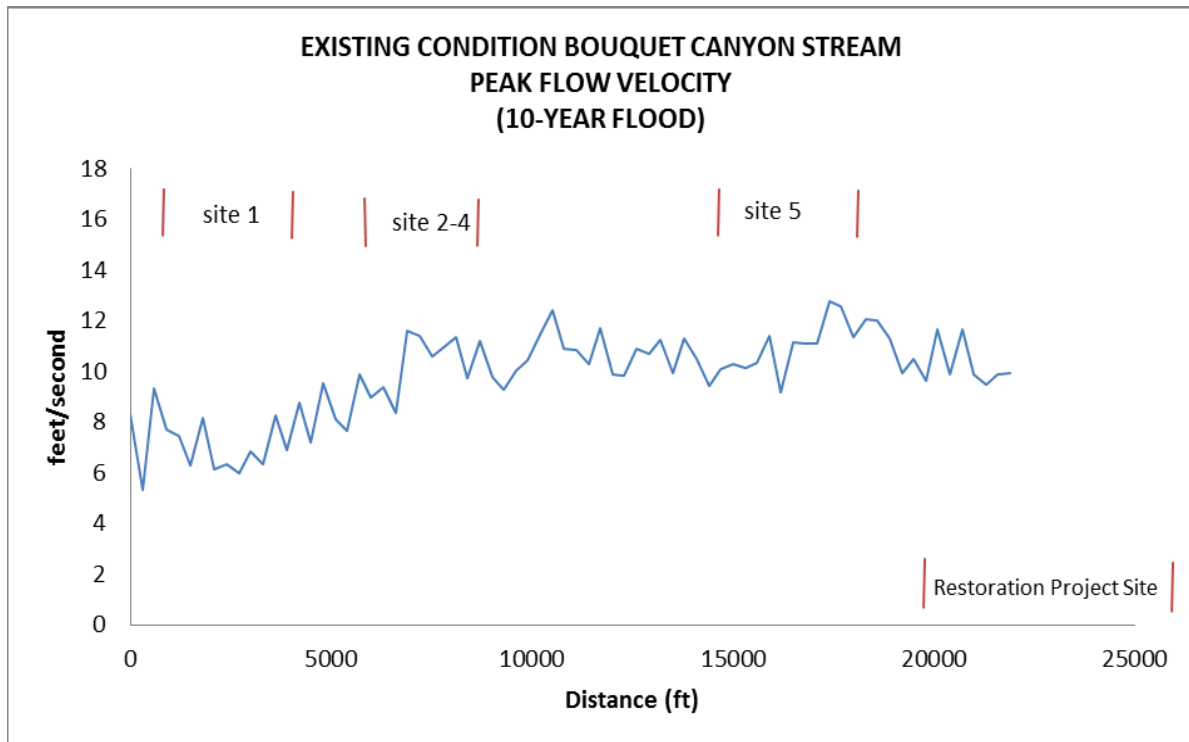
Figure 6. Bouquet Canyon Creek 10-year Flood Flow Velocity Profile under Existing Conditions

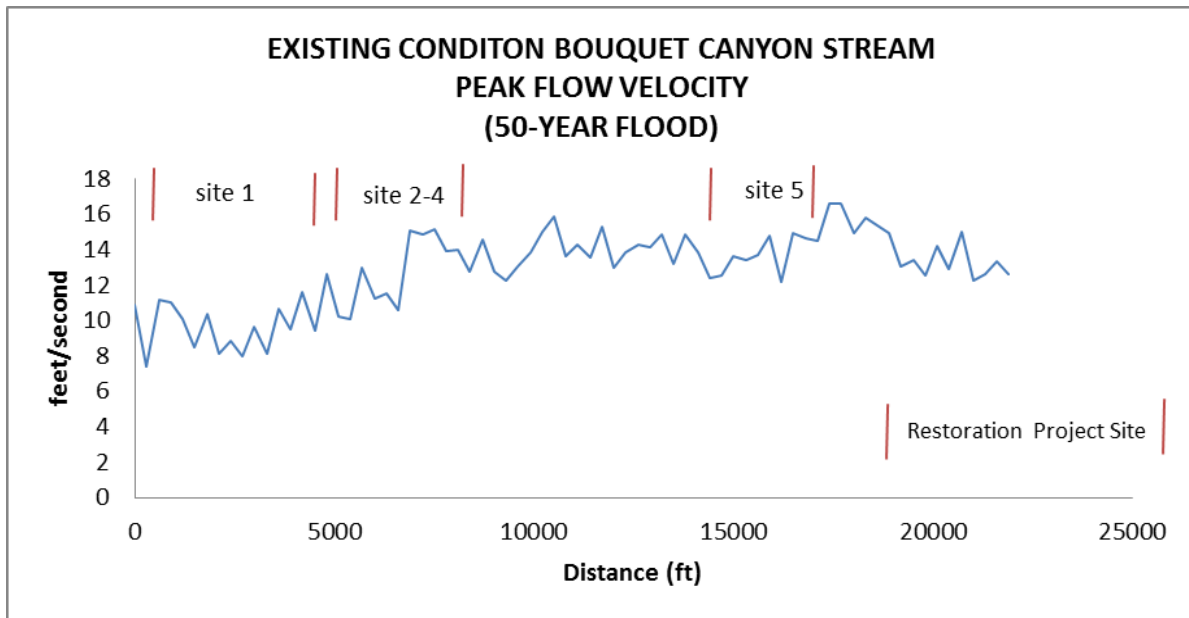
Figure 8. Bouquet Canyon Creek 50-year Flood Flow Velocity Profile under Existing Conditions

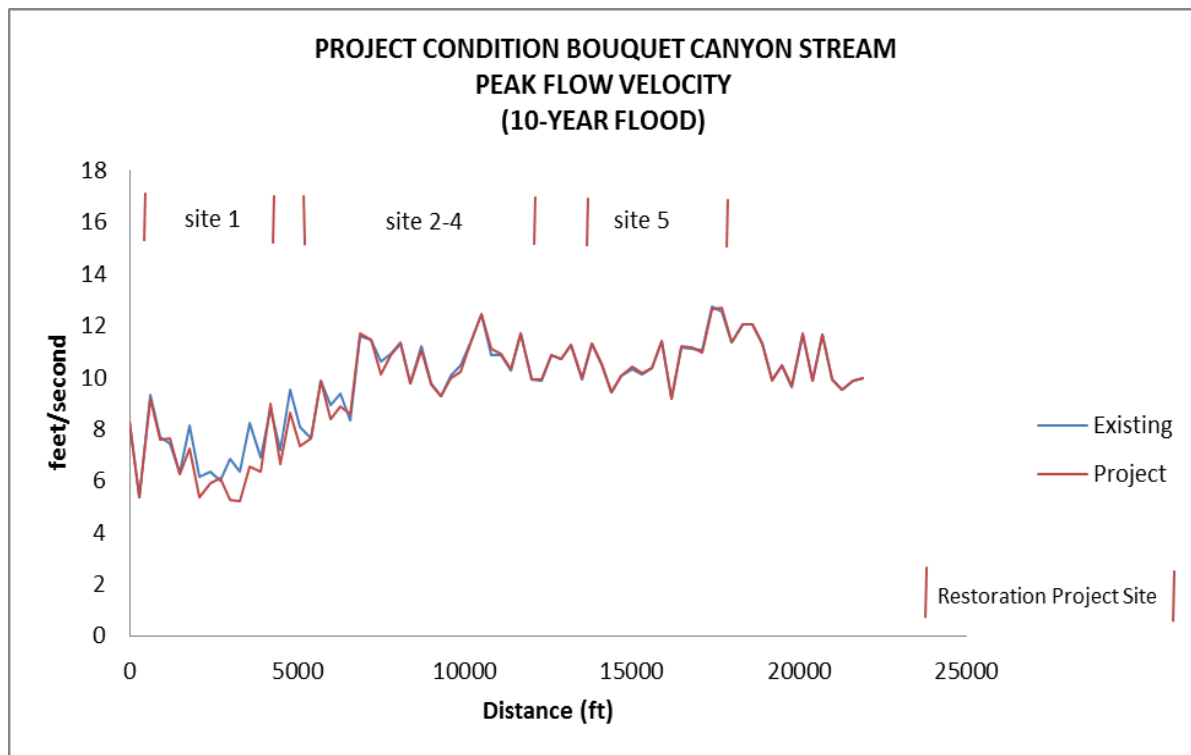
Figure 26. Bouquet Canyon Creek 10-year Flood Flow Velocity Profile under Project Conditions

With implementation of the project, the Bouquet Canyon Creek stream would be modified in the five project sites with stabilized slopes and greater conveyance capacities. For comparison, the computed project conditions flow velocity profiles were plotted together with those generated for the existing conditions and they are shown in Figures 24 through 28.

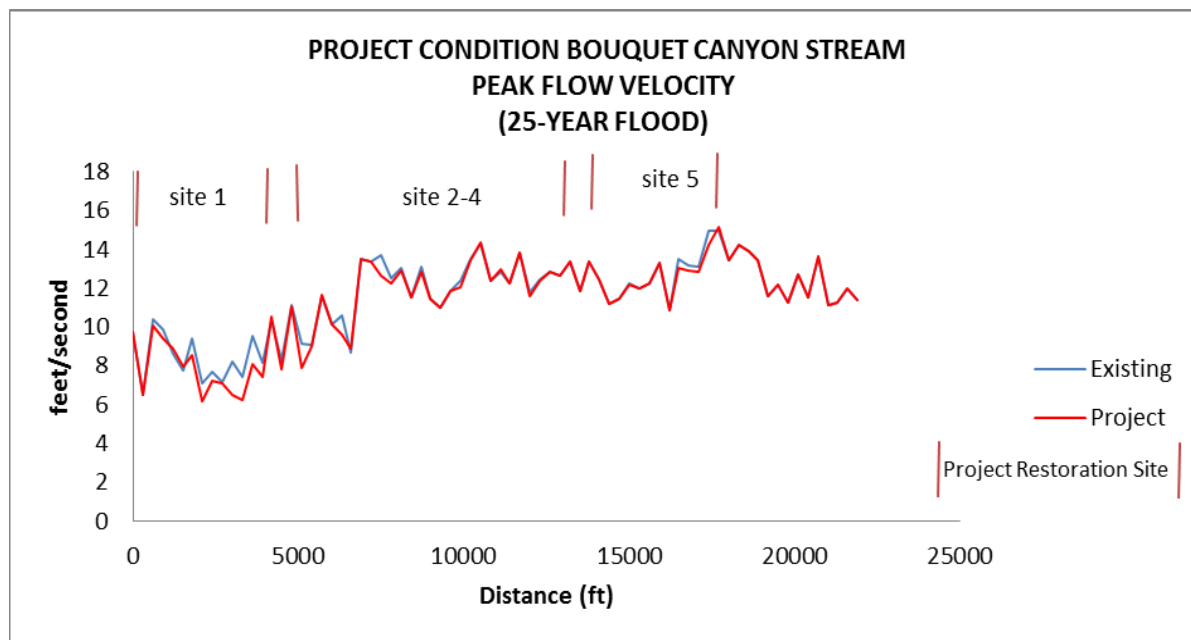
Figure 27. Bouquet Canyon Creek 25-year Flood Flow Velocity Profile under Project Conditions

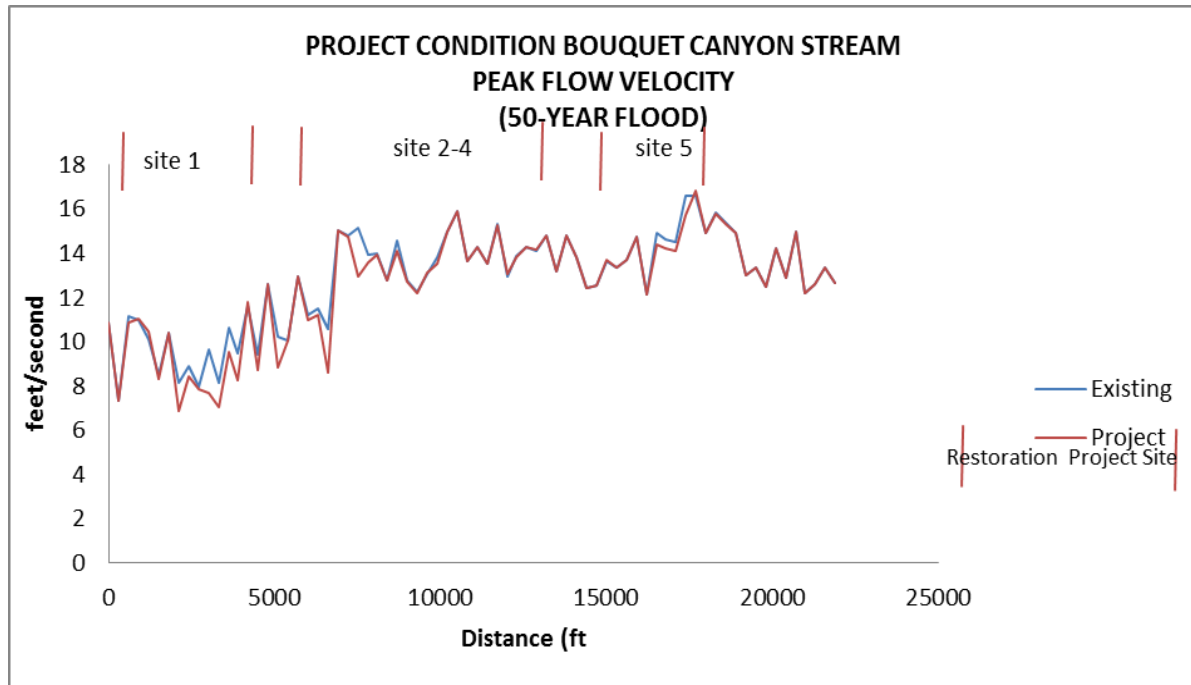
Figure 28. Bouquet Canyon Creek 50-year Flood Flow Velocity Profile under Project Conditions

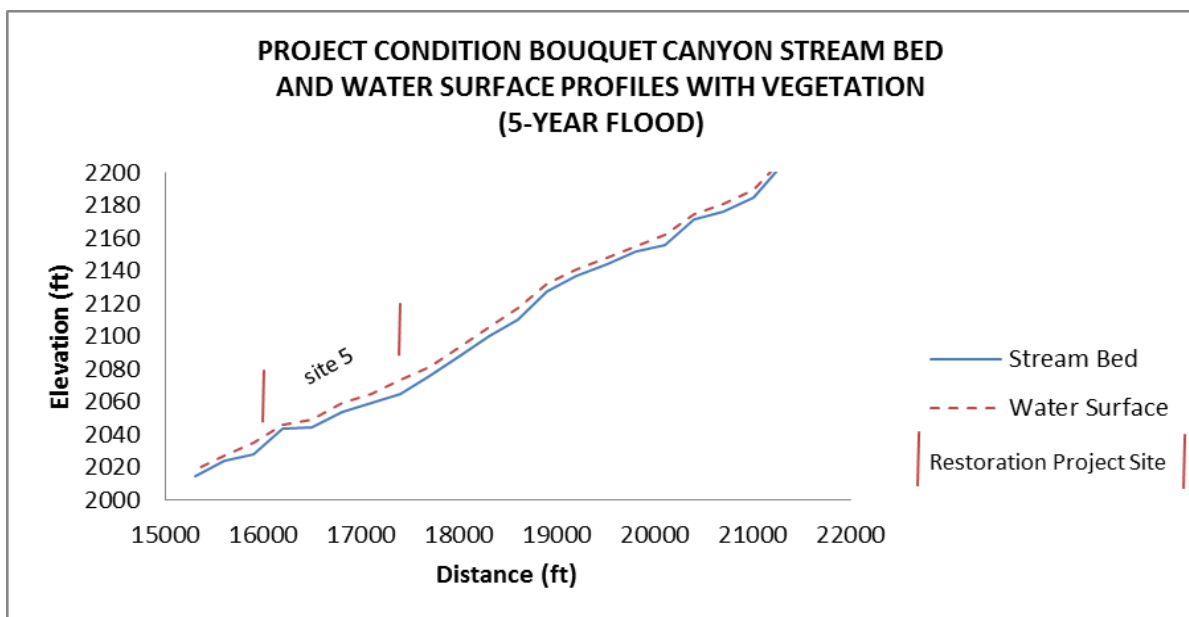
Figure 34. Bouquet Canyon Creek 5-year Flood Water Surface Profile under Proposed Conditions (Site 5)

The project condition water surface profiles were plotted and are shown in Figures 29 through 43.

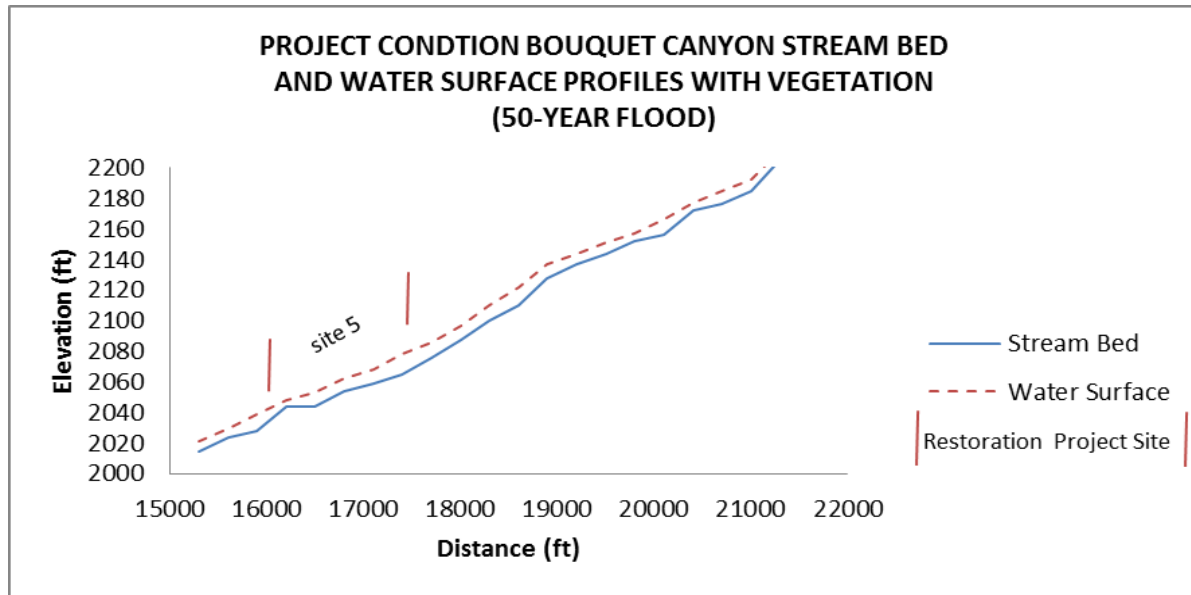
Figure 43. Bouquet Canyon Creek 2-year Flood Water Surface Profile under Project Conditions (Site 5)
